TRIUMF e-linac technical issues

Friedhelm Ames

ERW workshop May 10, 2022

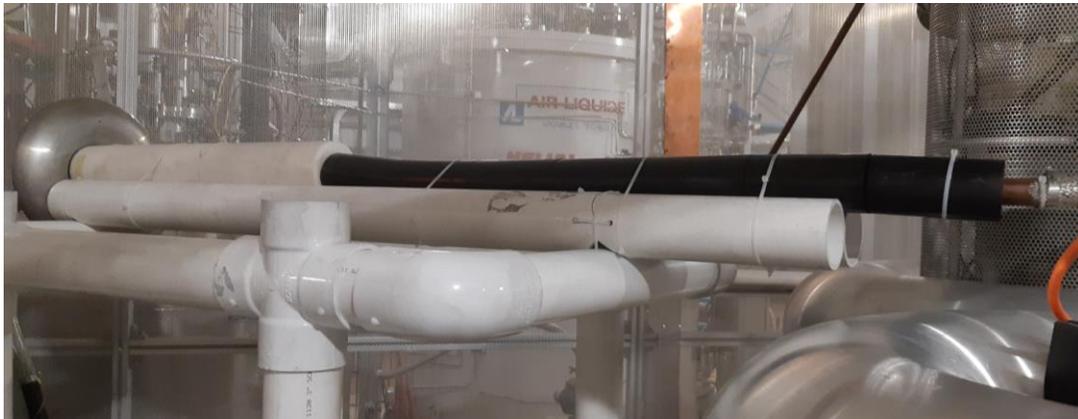
Sleeve over cable

- Sparking along high voltage cables
- Tracking inside connectors

- adding isolating sleeves to reduce field strength at cable and connectors
- implementing shorter maintenance intervals for cleaning and greasing of connectors

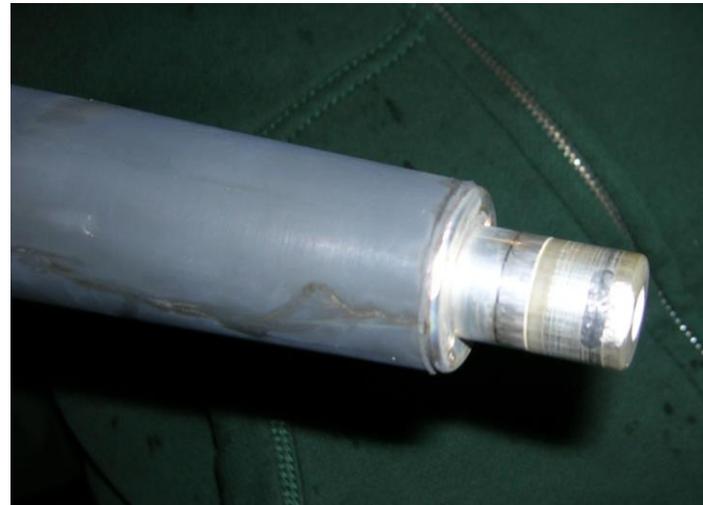
Tracks on connector plug

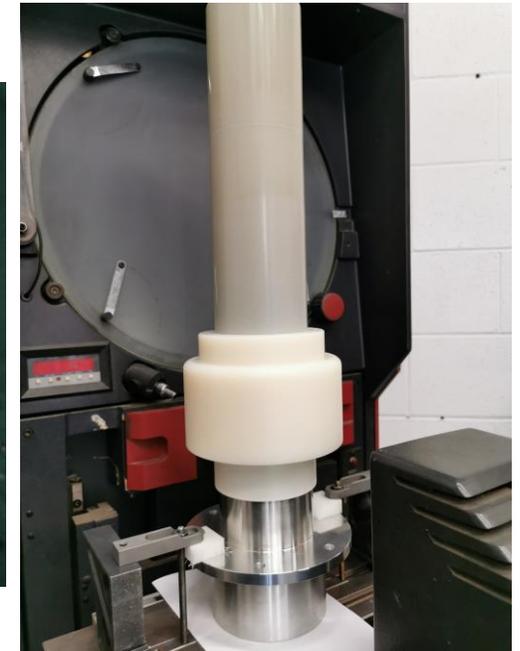
Sleeve over receptacle

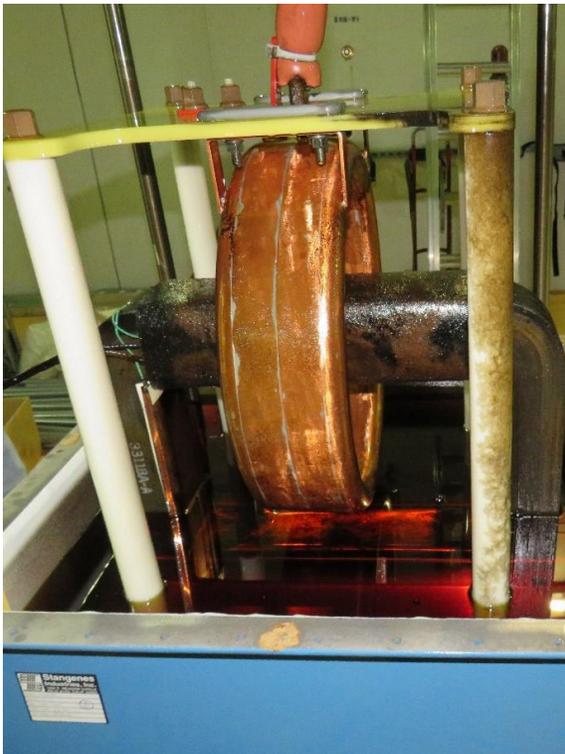
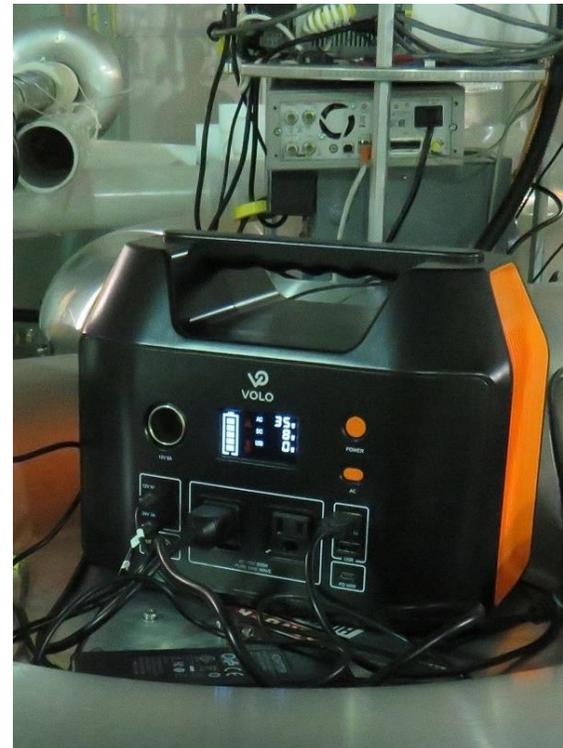
- Break down of high voltage isolation transformer
Manufacturer unable to supply → replace transformer by generator
preliminary work around: battery on high voltage

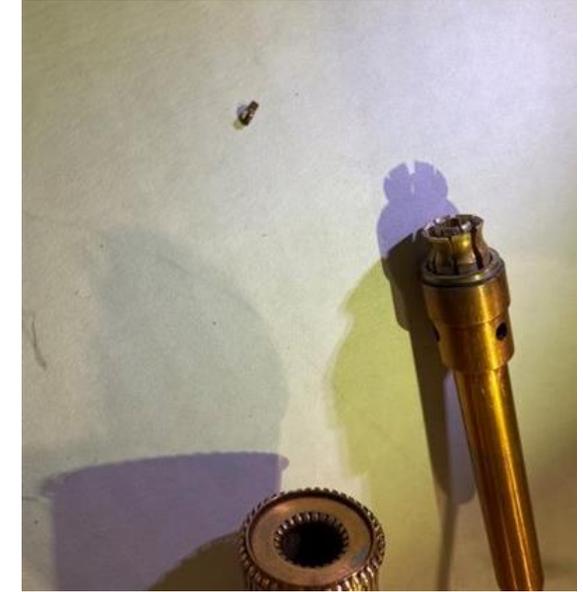
- Mechanical resolution not good enough
- low reproducibility
- Not stable due to thermal sensitivity and bad rf contacts

Broken fingerstock
caused short of grid voltage

Mitigation: redesign started

- Mechanical movement via hydraulic piston to decouple from SF₆ tank and improve resolution
- New concept: Moving dielectric components in the tuner to avoid rf contacts

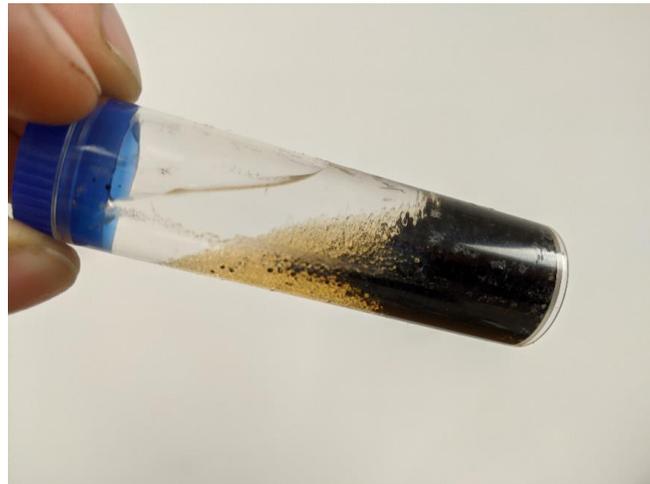
- Clogging of cooling channels at beam dump by resin particles verified by thermal images
- Low water flow at klystron rf window

Resin particles in water sample

→ Install more and better filtration

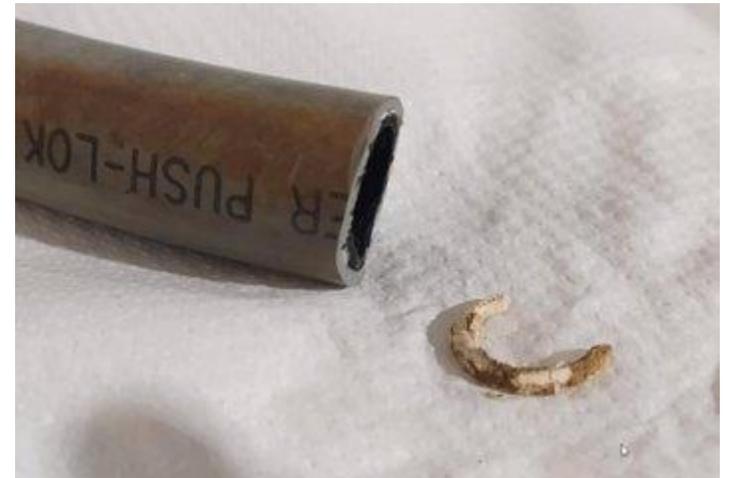
Part found close to rf window
