# ATLAS ITk strip detector – R&D and integration

Jiayi Chen (SFU)

TRIUMF Science week

July 25, 2024

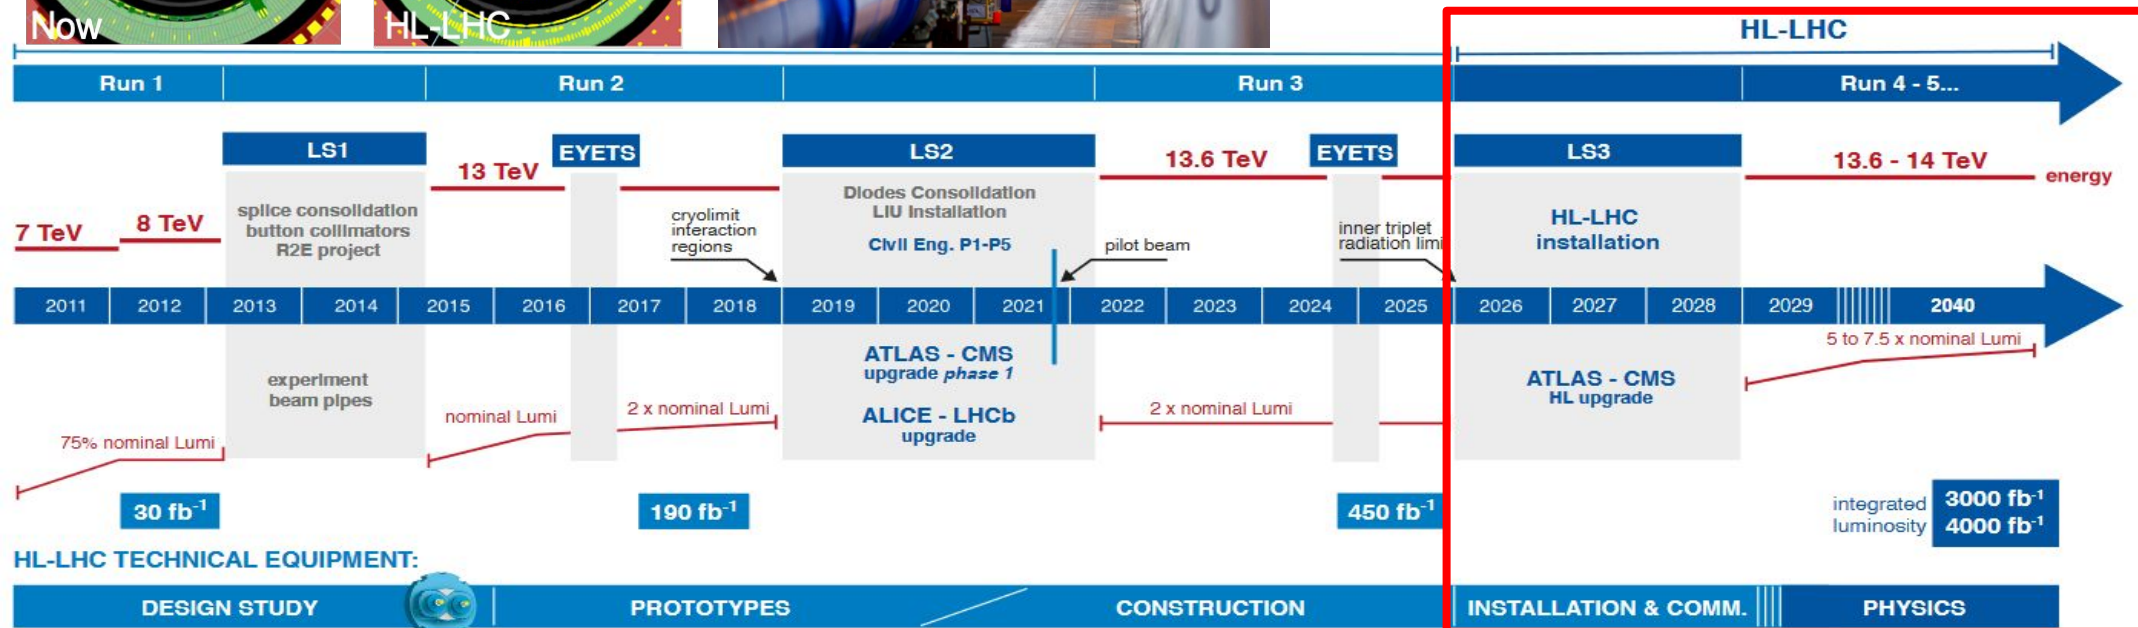
The **HL-LHC** will increase the complexity of LHC collisions!

- Luminosity increase by 10x wrt design, much higher radiation
- Number of inelastic (pileup) collisions from ~45 to 200 per bunch crossing
- Large track multiplicity up to 10,000
- Harsh environment: **ATLAS experiment needs to be upgraded!**

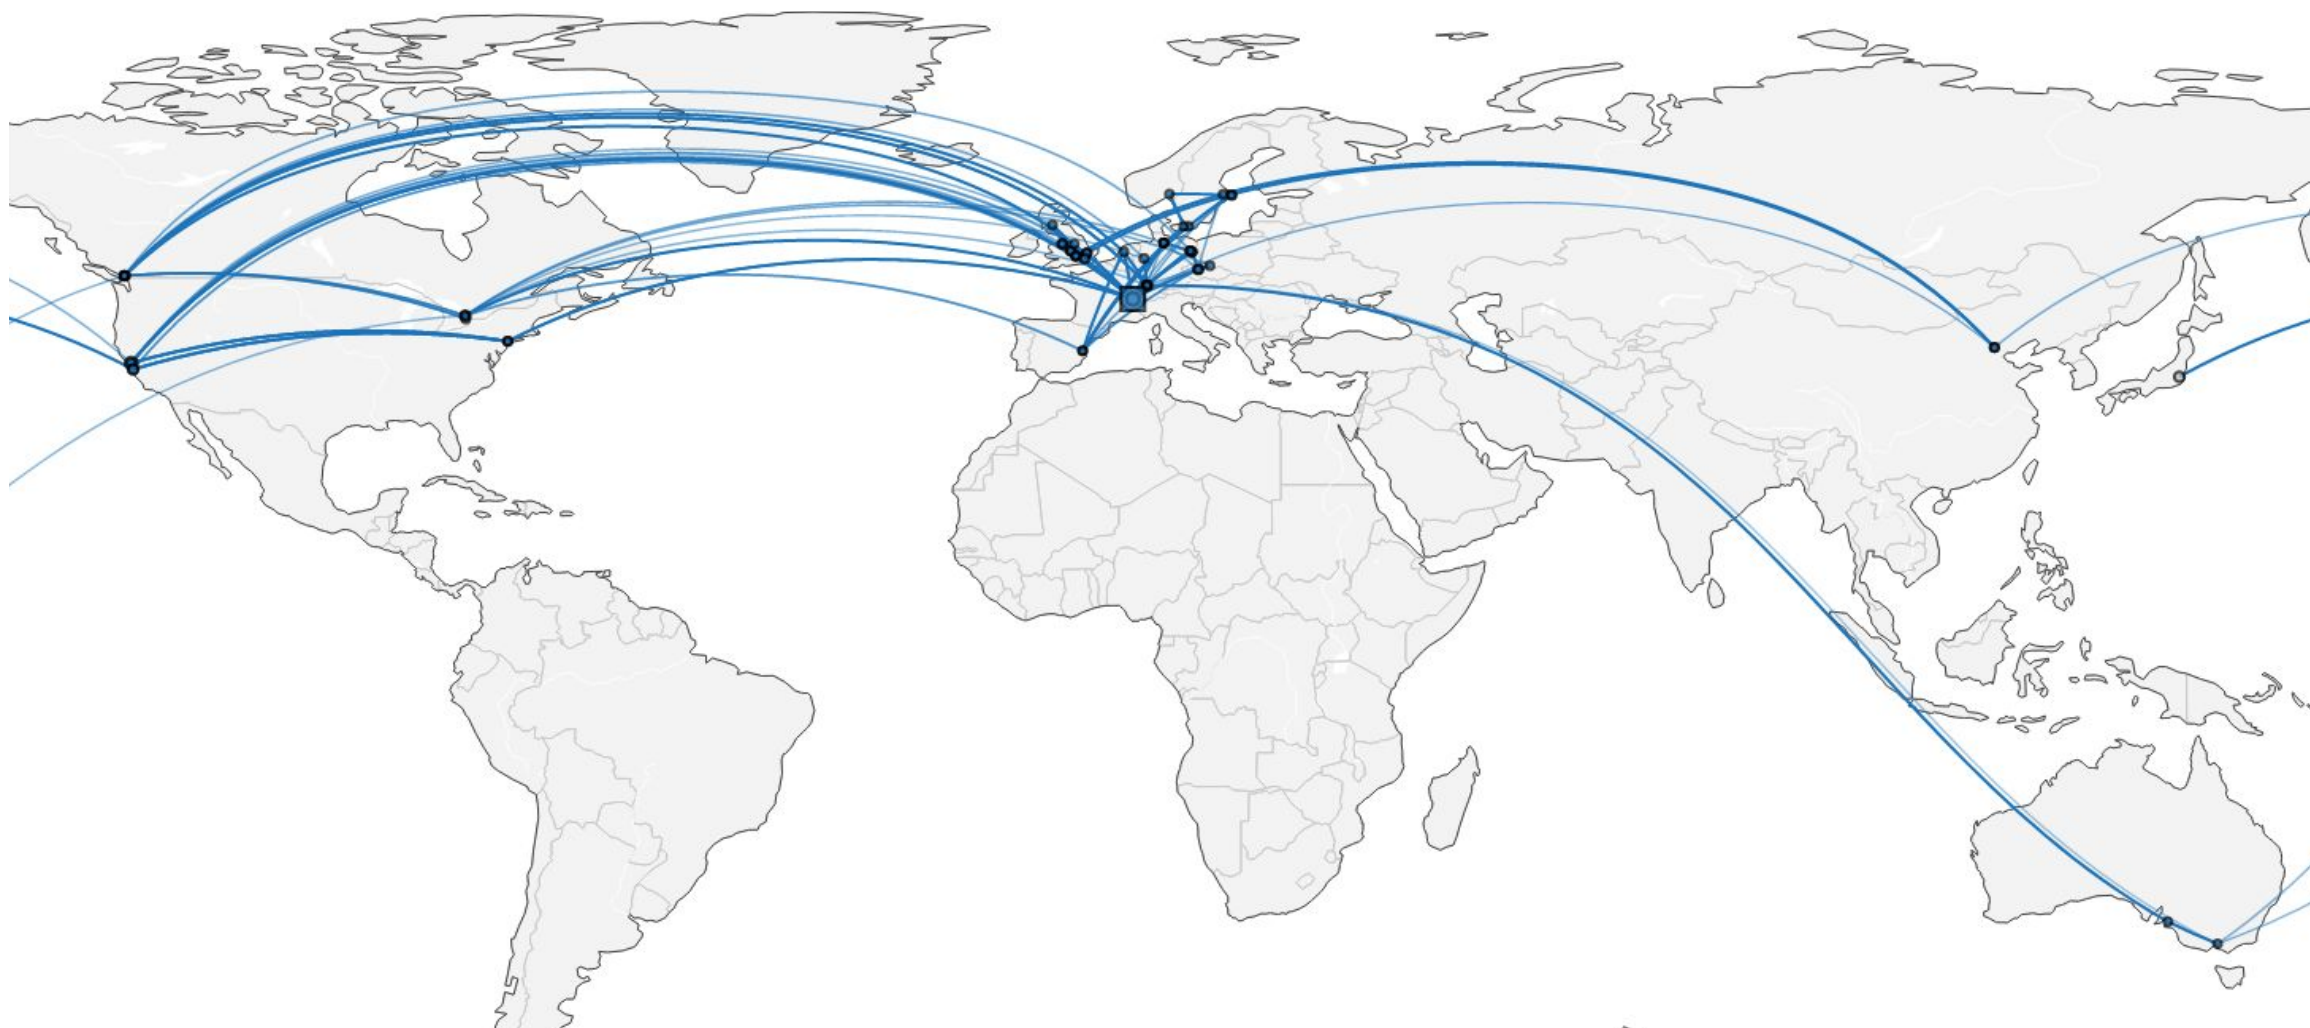
- ITk strip detector production takes place at around 60 institutes in 14 countries around the world

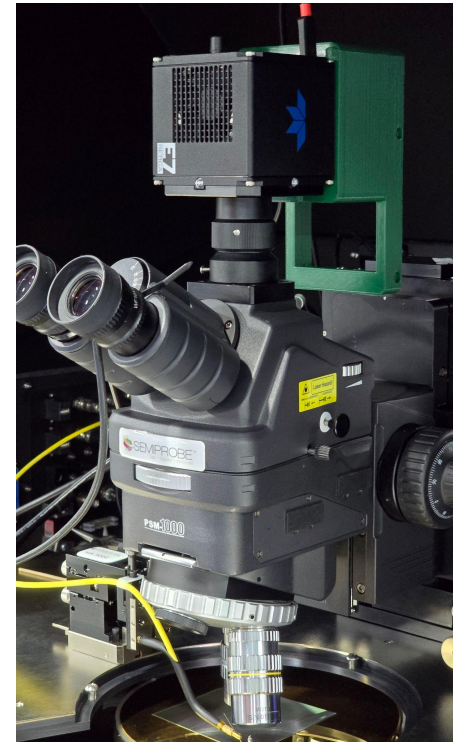
- **Early leakage current breakdown** (An unexpected significant increase in leakage current shown below) is a common failure mode for silicon based particle detectors, but its source was normally assumed and not verified.  
- The **Hot Spot setup** using the Retiga E7 (left) can capture emissions of hot electrons from silicon breakdown, allowing us to **identify** the damage **source** and better understand failure modes.

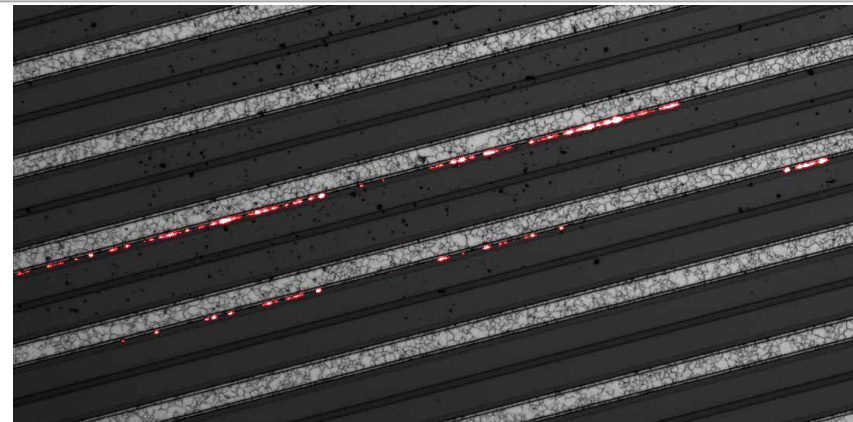
- Emissions can be seen (left) along the edge of strips on an ATLAS endcap sensor. These were caused by damage to the protective passivation layer on the sensors surface.

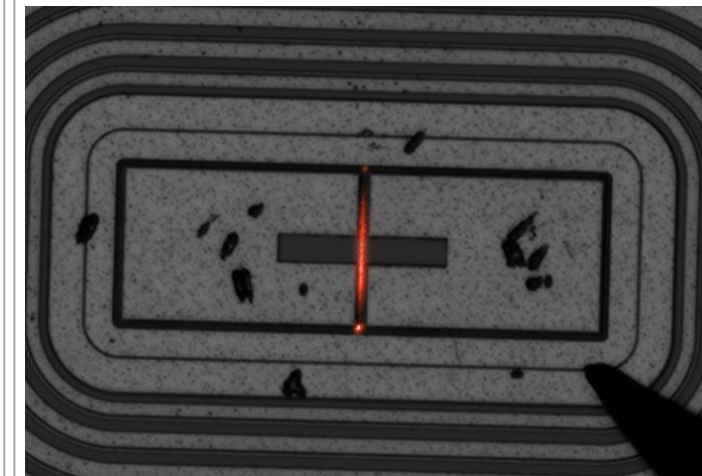
- Emissions can be seen (below) along the inner edge of the guard ring of a test structure diode. This breakdown was induced by irradiating the sample heavily.

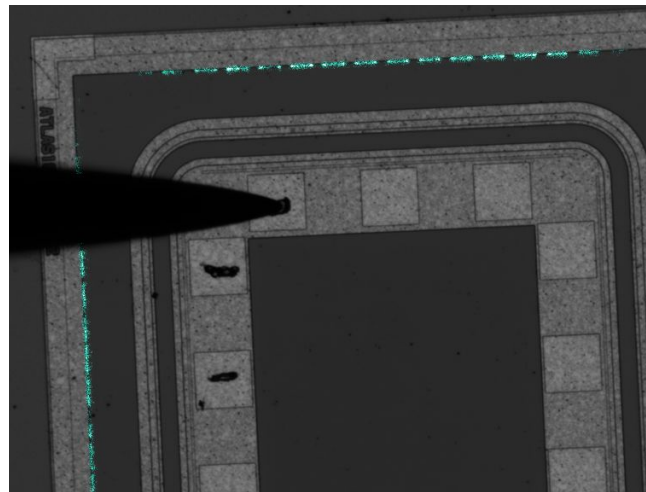
- Emissions can be seen (above) originating from the trench of a damaged Trench Isolated LGAD device.

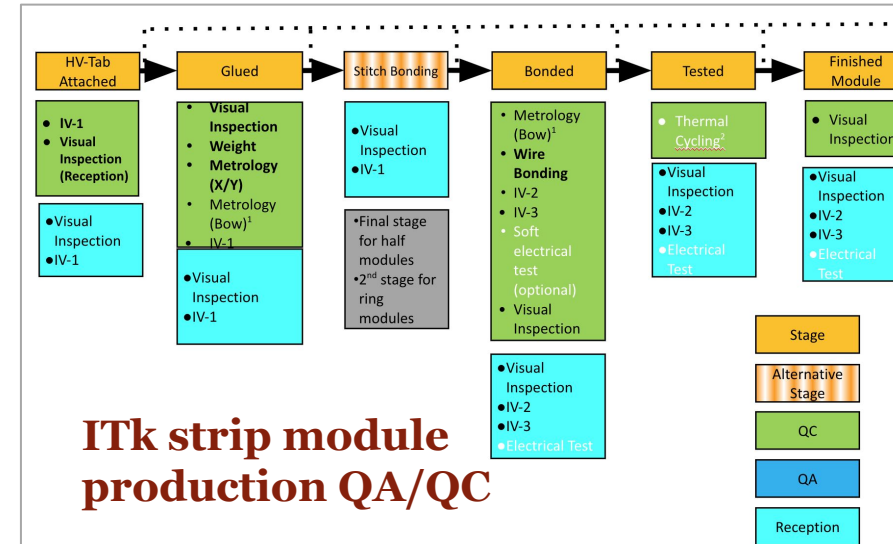
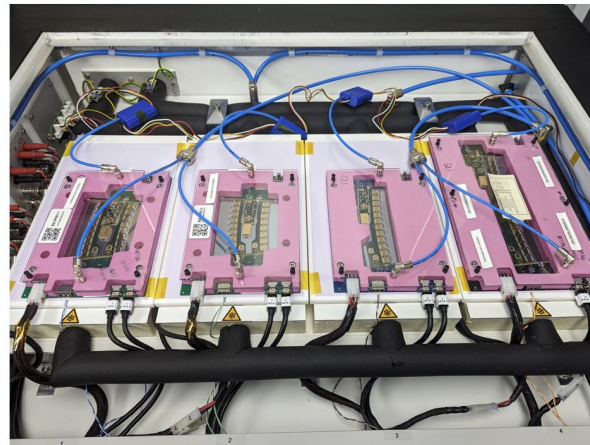
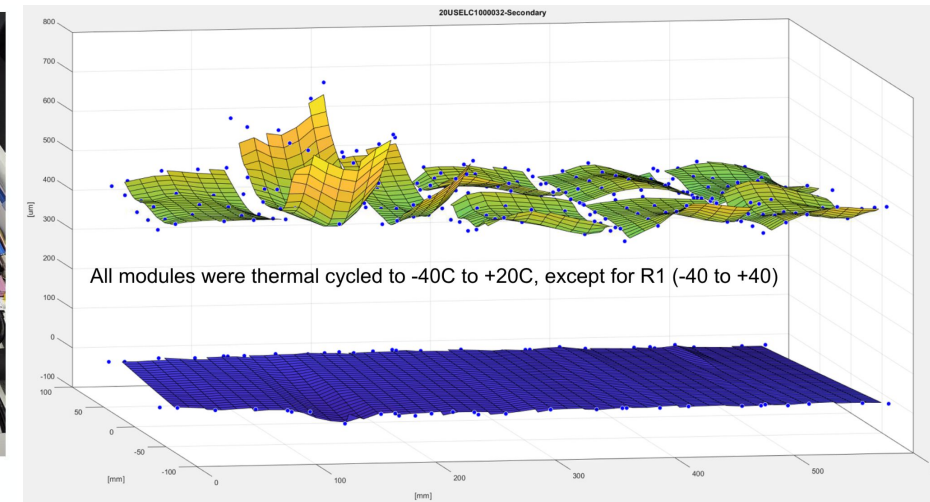
- Module production is streamlined with assembly and QA/QC procedures, e.g.
  - IV scan (look for early breakdown)
  - metrology (measured module bow)
- *Quality concerns caused by quality control - deformation of silicon strip detector modules caused by thermal cycling tests (Richard Salami, et al.)*
  - As part of the QC, modules were requested to be thermal cycled between -35C and +40C
  - Investigation shows this process deforms the module shape
  - thermal cycle now modified to temperature from +40C to +20C, matching the maximum operating temperature.

- As part of the qualification control procedure, modules were requested to be thermal cycled between -35C and +40C. An investigation has shown that this process deforms the module shape and therefore calls for modification to the thermal cycle procedure which now reduced temperature from +40C to +20C, matching the maximum operating temperature.

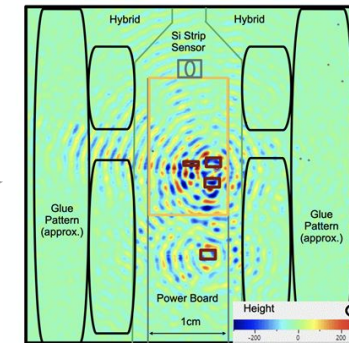
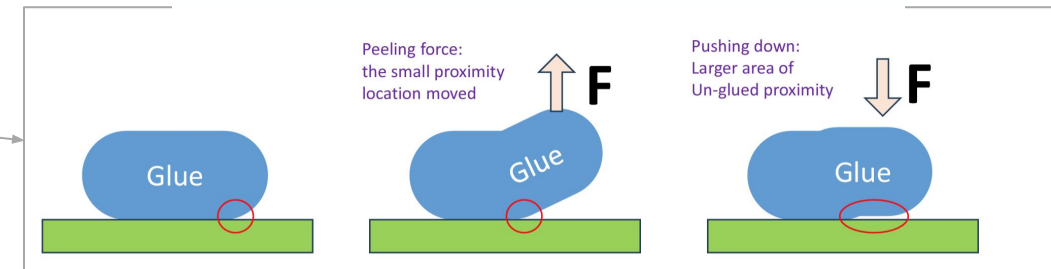
- Expect noise level at low temperature to be less, however, observed clusters of **noisy channels** around **-35C** and some remaining noise even after going back to warm

- noisy channels only in rows of strips below the power board
- source identified to be **mechanical vibrations** from capacitors on the power board travelling through the sensor and inducing electrical noise

- Laser vibrometer shows mechanical vibrations propagating through sensors
- Current theory under investigation: cooling cause hybrid to bend and glue to peel off under hybrid edge, releasing charge

- Mitigation strategies:
  - No cold noise on Endcap modules (magnitude of vibrations on endcap modules is  $\sim 10x$  smaller)
  - No cold noise in long-strip barrel modules using new type of glue

- Cold noise reduced but still detectable in SS modules with new glue type
- Cold noise no longer blocks the start of module production

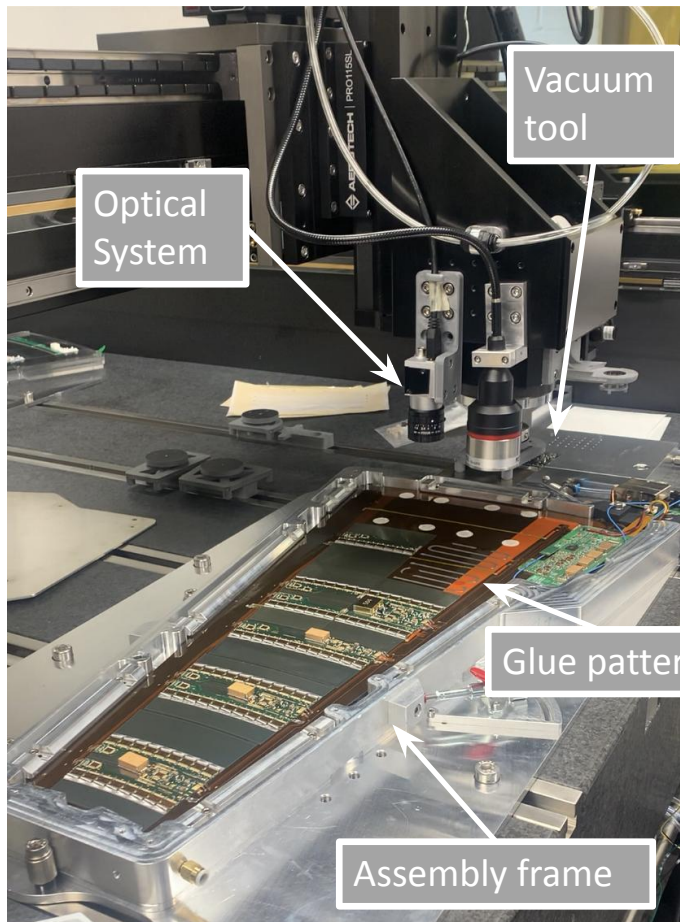
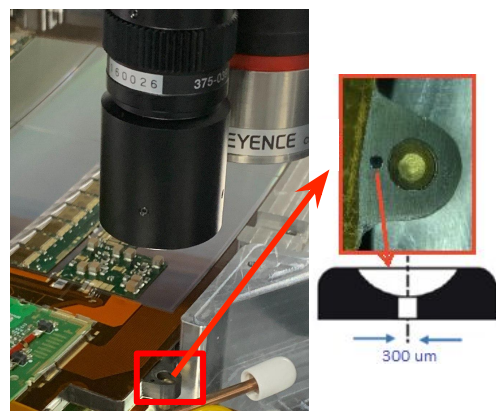
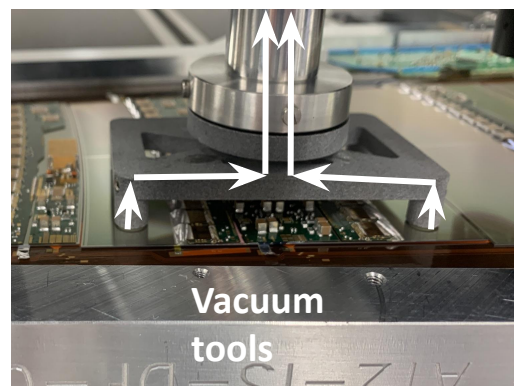
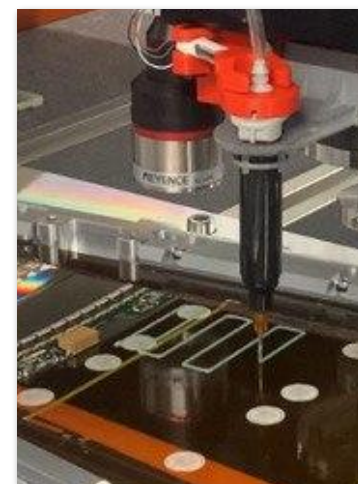
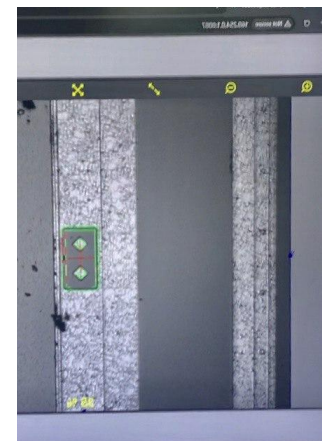
- Automated petal loading: Matlab program that controls robotic gantry to

- calibrate between lab frame and petal frame

- pick up and place modules precisely (well within 50-micron specification)

- Dispense adhesive (thermal conductivity)
- 3D metrology and visual capture
- picture shows field of view from mega-pix cameron on gantry

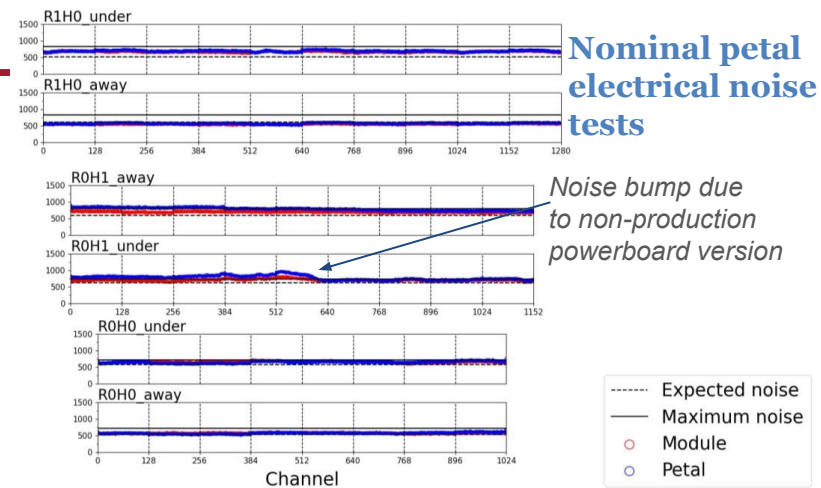
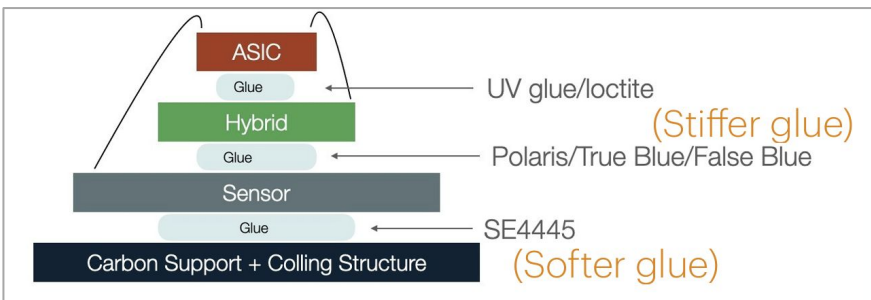
- **Nominal** QC temperature is **-35C** and noise **consistent before and after loading**
- For temperatures **colder than -35C**, some sensors have early breakdown after loading and visual inspection manifested these sensors have **cracks**
  - source is mismatch of thermal expansion between sensor and electronics
  - -35C is the planned end-of-lifetime temperature, the **goal** is to have **sufficient headroom** to accommodate cooling plant issues / potential failure modes
  - several mitigation strategies are experimented at Vancouver

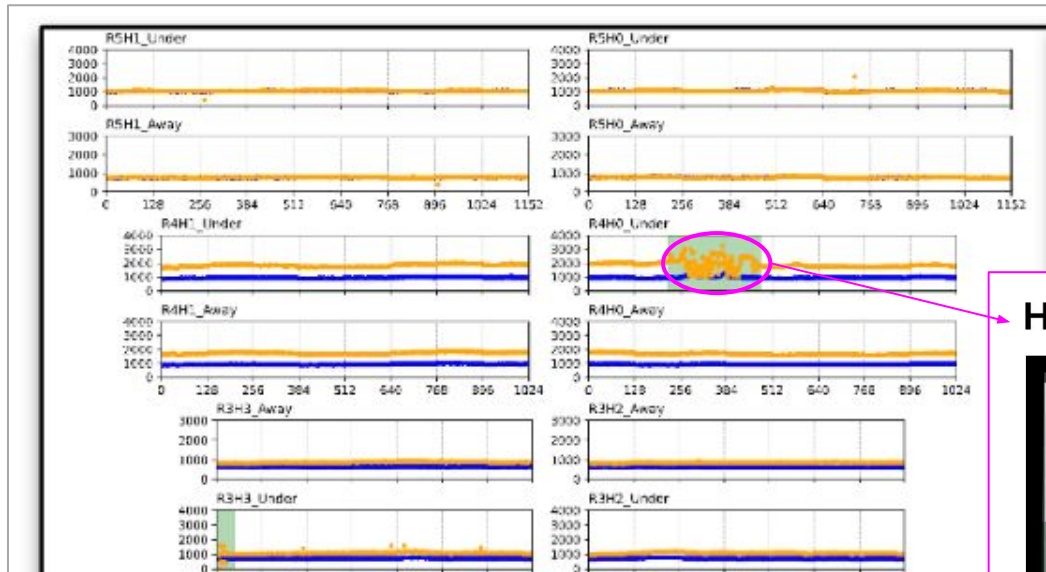
- cracking signature: cluster of channels with “bumpy noise”
- Example from the **1st Hysol petal** built at Vancouver
- Cracking is suspected via noise and IV and later visualized under microscope

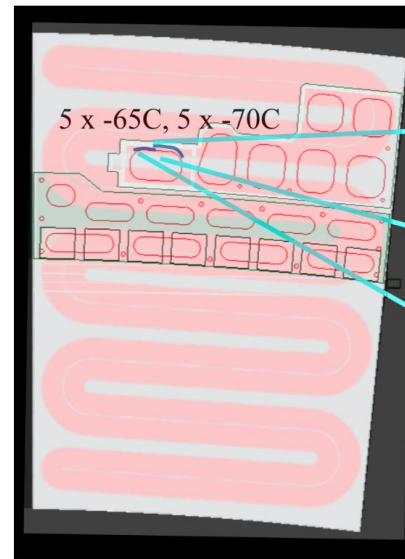
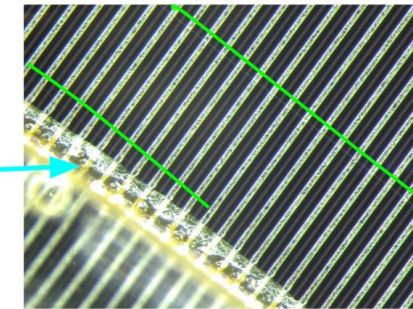
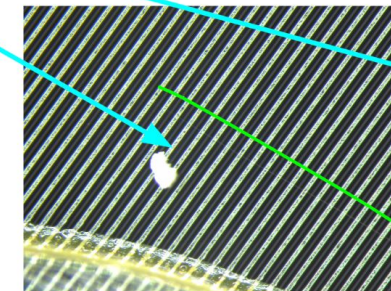
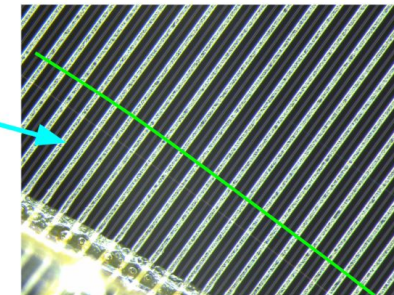
HYSOL S Side R4H0

Both cracks follow glue edge

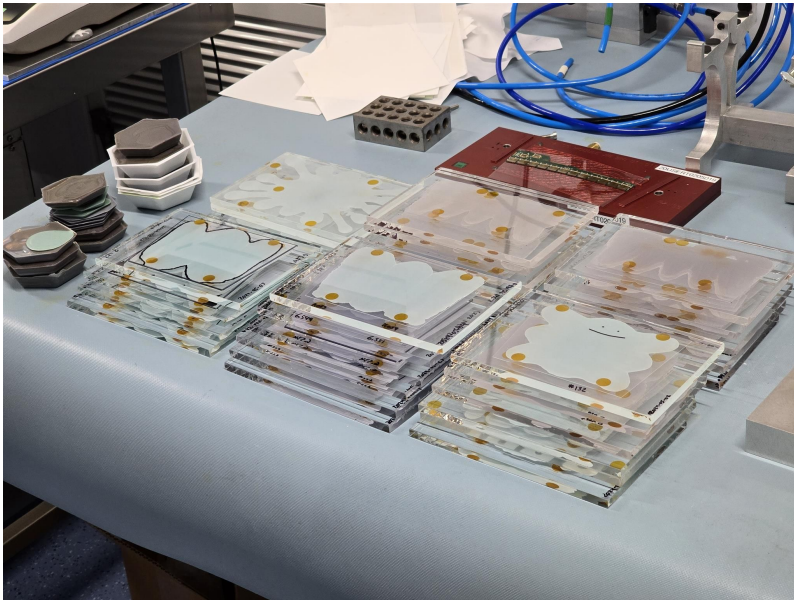
- After the 1st Hysol petal, an **enormous** amount of work was devoted into glue test, finding the optimal glue coverage
  - see pictures of glue test using plexiglass
- 2nd Hysol petal was freshly built early July and just went through the first week of thermal cycle
  - currently only have one suspected crack (seeing bumpy noise feature), but this petal is undergoing more cycles at the moment to deliver more confirmative results
- The test will continue and other mitigation strategies will also be explored (e.g. adding kapton layer for module)

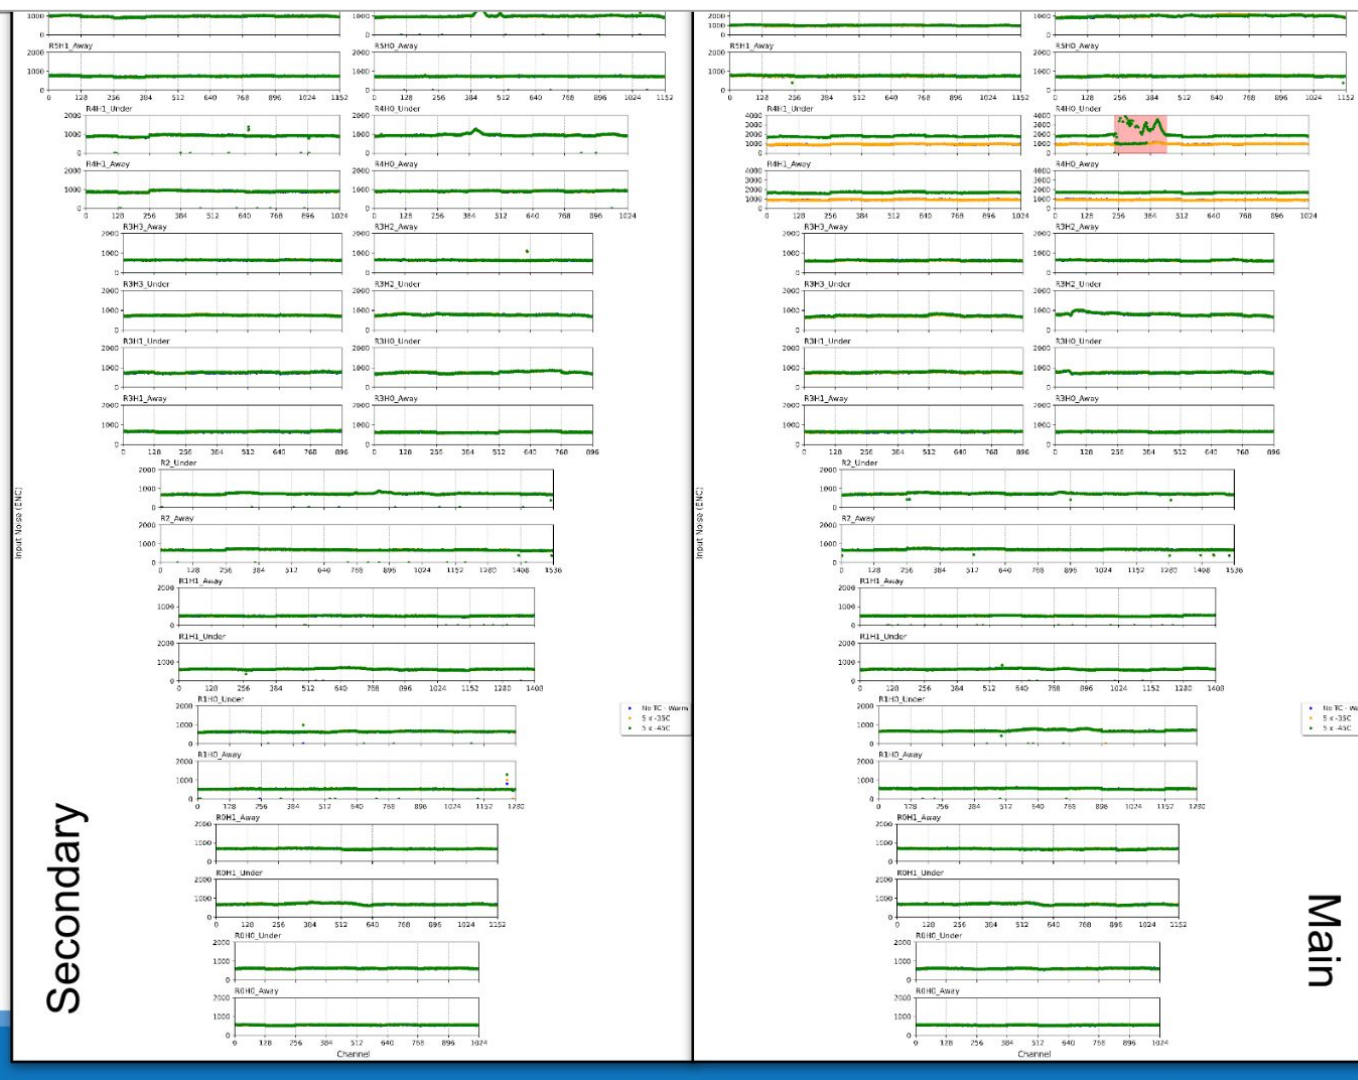
- 2nd Hysol petal noise after TC

Full coverage petal  
(tested down to -45C)

Blue: No TC - Warm

Orange: 5 x -35C

Green: 5 x -45C

- Petal cycled to temperature lower than end-of-lifetime temperature (-35C) or QA (-55C)

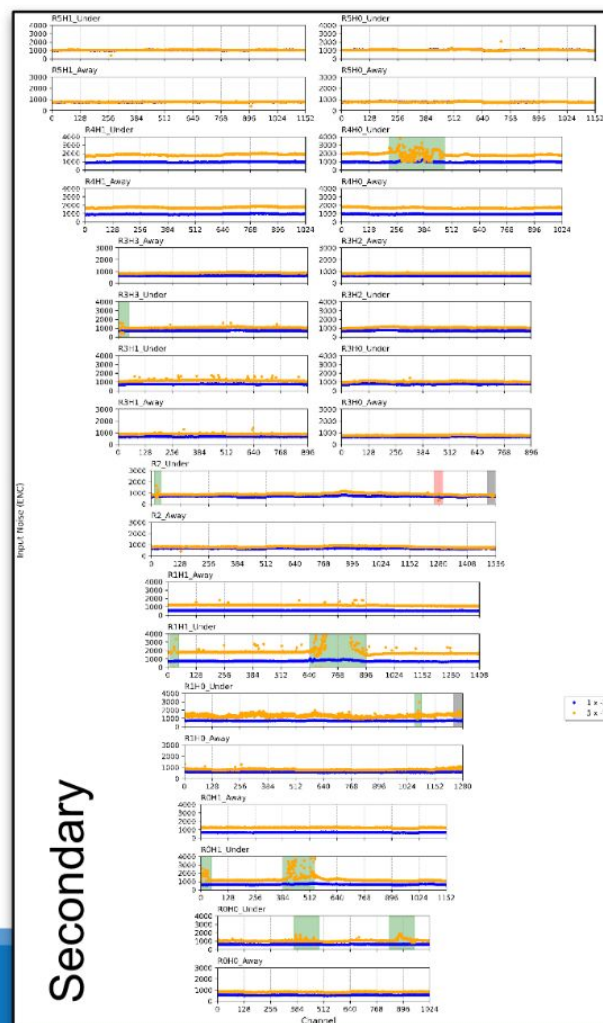
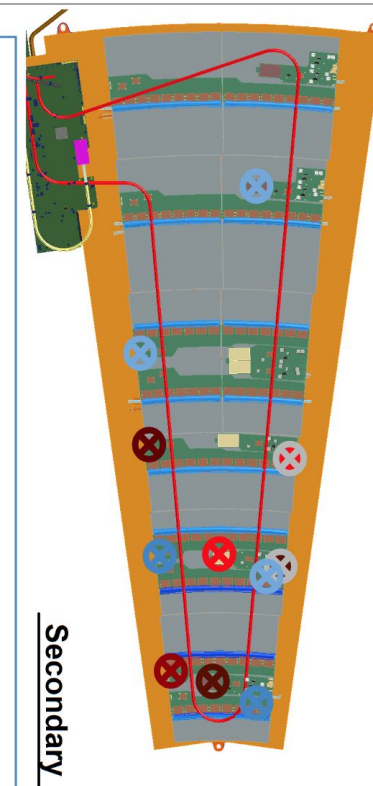
## Crack Location Noise Overview

**Green** highlight: seen visually  
**Gray** highlight: not seen  
**Red** highlight: likely not a crack  
(feature present since no TC)

- Petal is cycled in climate chamber to temperature much lower than end-of-lifetime temperature (-35C)

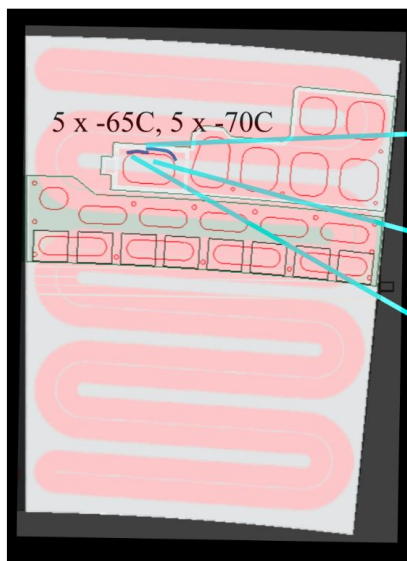
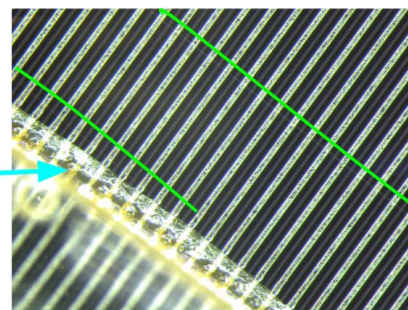
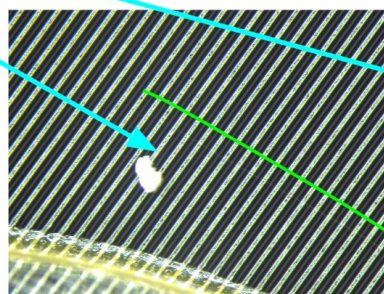
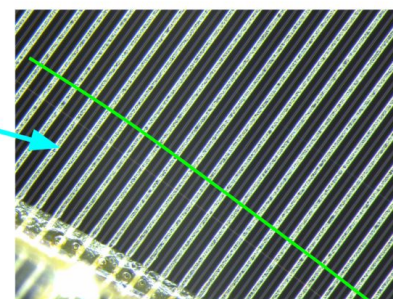
### HYSOL S Side R4Ho

Both cracks follow glue edge
