J-PARC muon facility report

J-PARC/KEK Akihiro KODA

Materials and Life Science Experimental Facility (MLF)

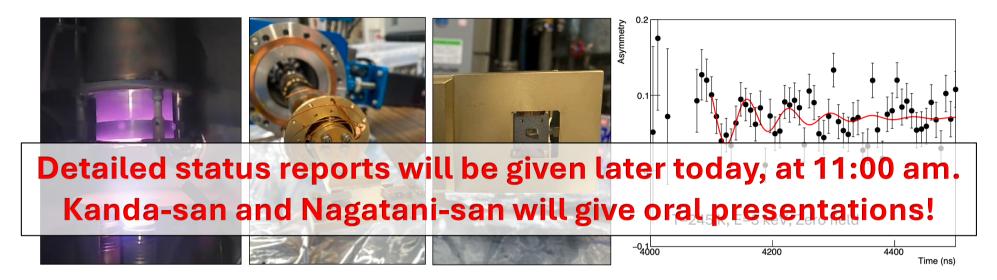
U-Line: First Scientific Campaign

Sample fabrication by pulsed laser deposition.

Thin film sample of Ca_{0.85}Sr_{0.15}CuO₂ mounted on the cryostat.

Preliminary result of the zero-field µSR measurement.

- First scientific measurements of USM-µSR has been started with a cuprate thin-film sample.
- A full-scale physics measurements involving the sample transportation, cooling, and control of implantation energy.
- Muon spin rotation originating from internal magnetic fields inside the sample was successfully observed.

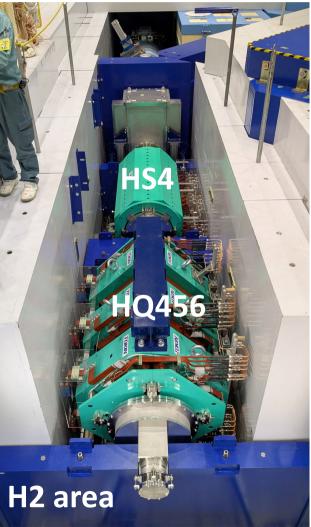
H-line: Upgrading of beamline

The final focusing magnets were installed.

The beam-commissioning will start in the next FY.
