# Building the new ATLAS tracking detector ...

## and some of the side quests we encountered in the process

July 28<sup>th</sup>  
TRIUMF Science Week 2025

# ITk, end-cap and Canada

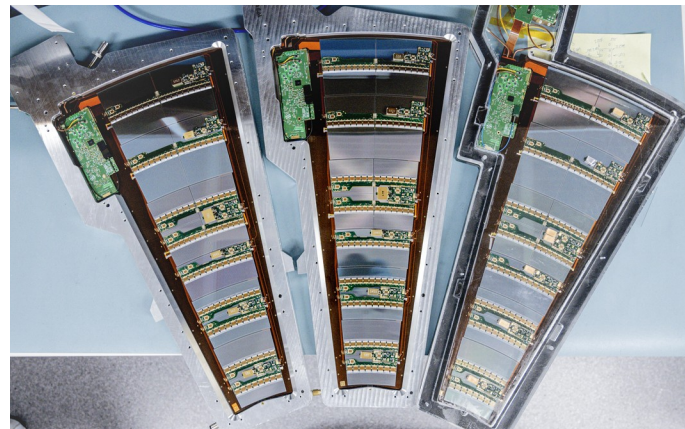
Petals (as they will be installed in the detector)

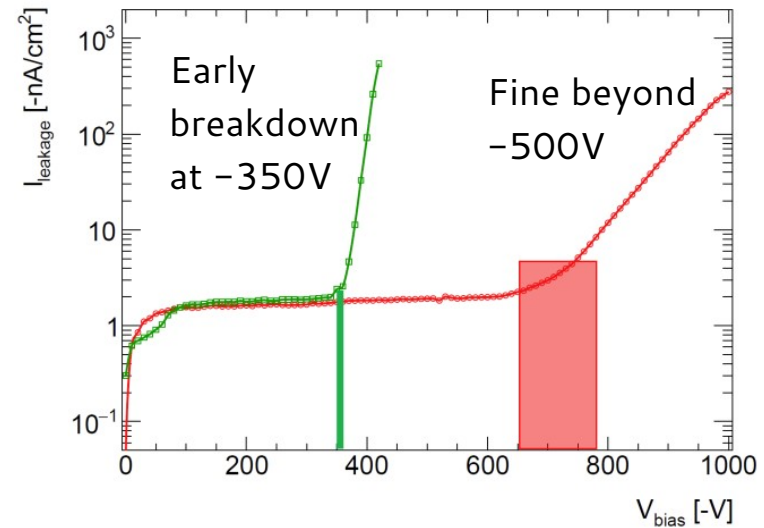
Sensors in detector are operated at  $-350$  V initially,  $-500$  V at end of life (for sufficient signal collection)

Requires sensor current to be  $< 10$  mA at  $-500$  V in initial tests

Ongoing and persistent problem:  
some sensors can't be used all the way up to the required bias voltage

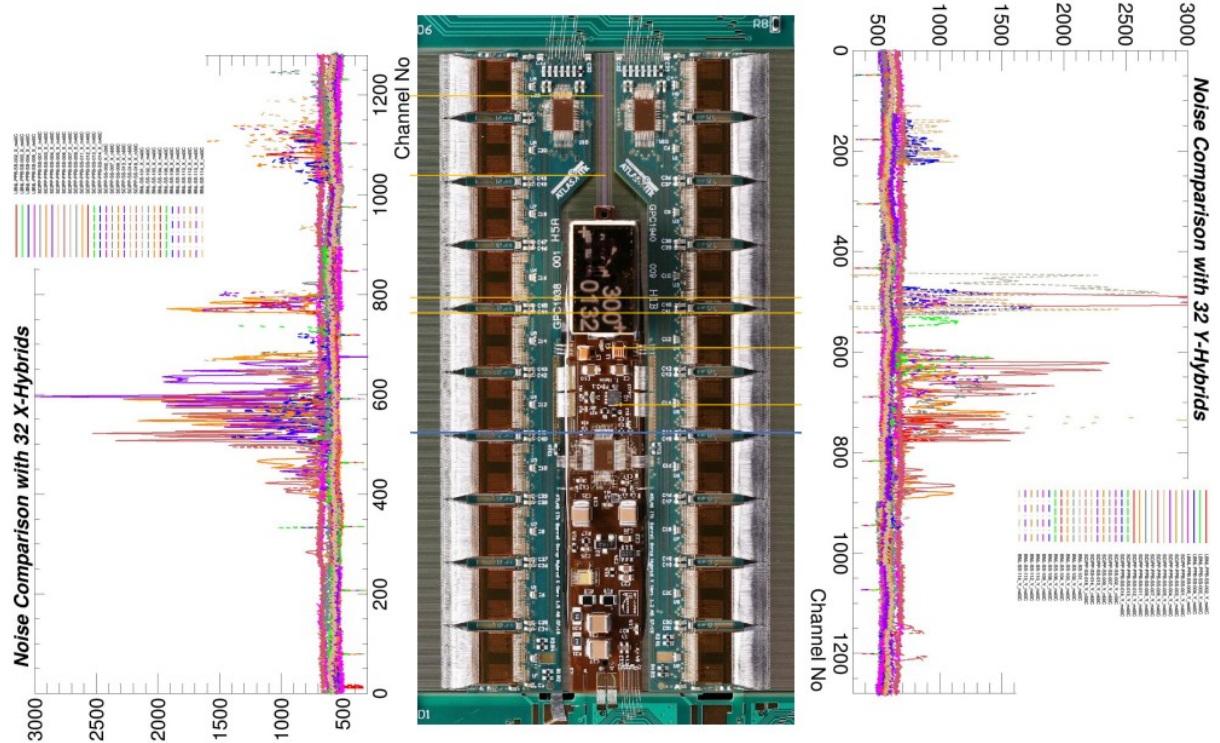
Excessive noise peaks which only occur at cold (operating) temperatures

Only on certain modules and types

Only in certain areas

Only for certain glue

Complex interaction of individual parts (vibrating capacitors on circuit boards, vibrations travelling through sensor and glue layers and somehow couple back into readout)

Solved by using a different glue in 2022 ...
