TRIUMF e-linac technical issues

Friedhelm Ames

ERW workshop May 10, 2022

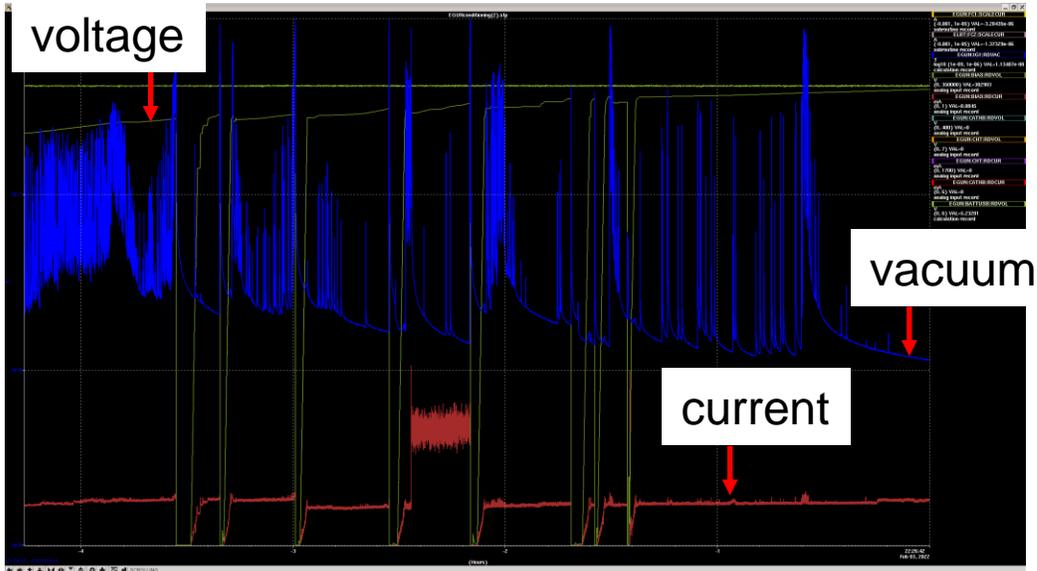
High voltage conditioning >275 kV

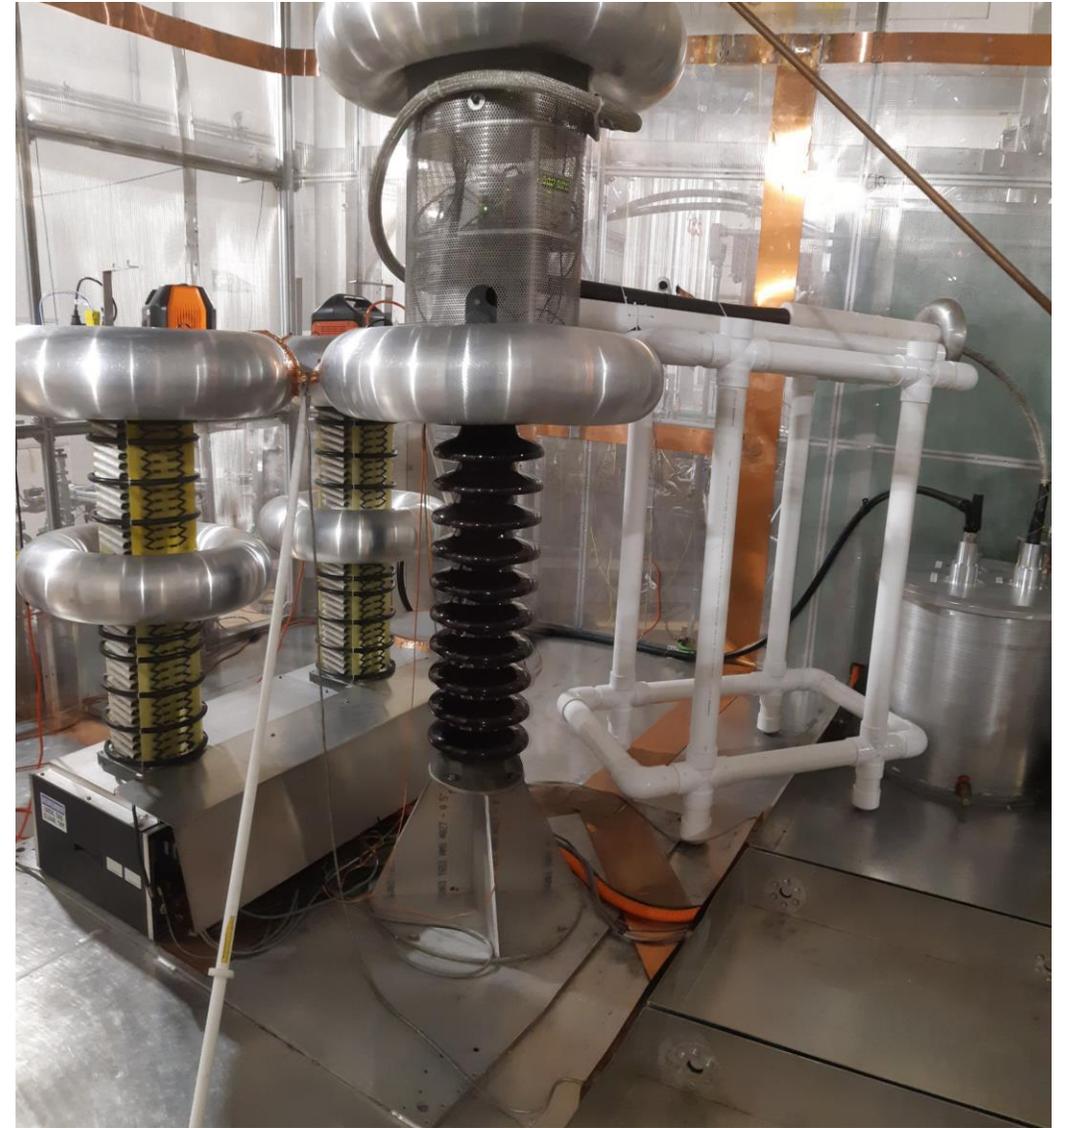
e-gun high voltage issues

- Sparking along high voltage cables
- Tracking inside connectors

- adding isolating sleeves to reduce field strength at cable and connectors
- implementing shorter maintenance intervals for cleaning and greasing of connectors

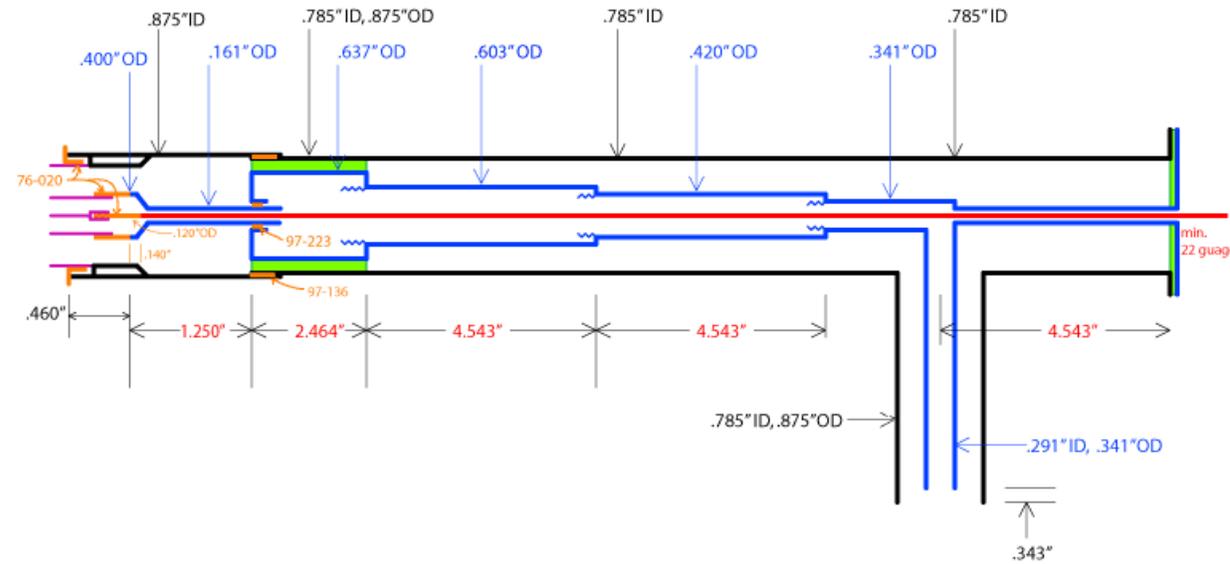
Issues:

- Mechanical resolution not good enough
- low reproducibility
- Not stable due to thermal sensitivity and bad rf contacts

Mitigation: redesign started

- Mechanical movement via hydraulic piston to decouple from SF₆ tank and improve resolution
- New concept: Moving dielectric components in the tuner to avoid rf contacts

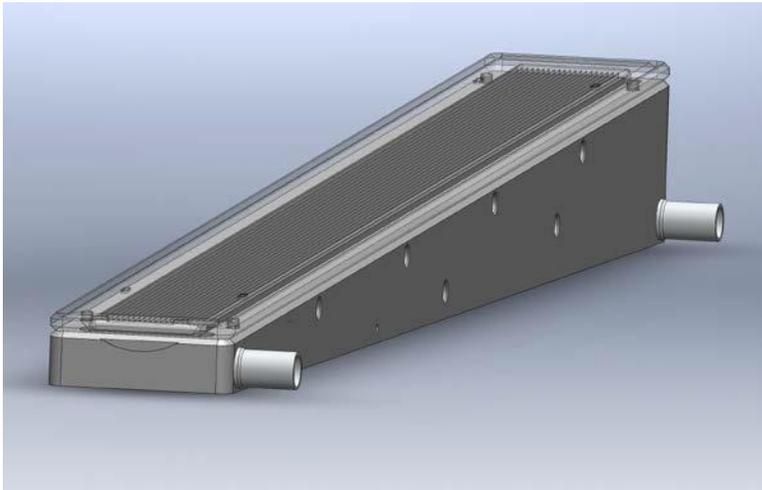
Model of beam dump

Problem particulates in the cooling water

- Clogging of cooling channels at beam dump by resin particles verified by thermal images
- Low water flow at klystron rf window

→ Install more and better filtration
