Current ISAC Target Infrastructure Strategy

Alexander Gottberg
Department Head, Targets and Ion Sources

ISAC Strategy Workshop
November 08, 2019

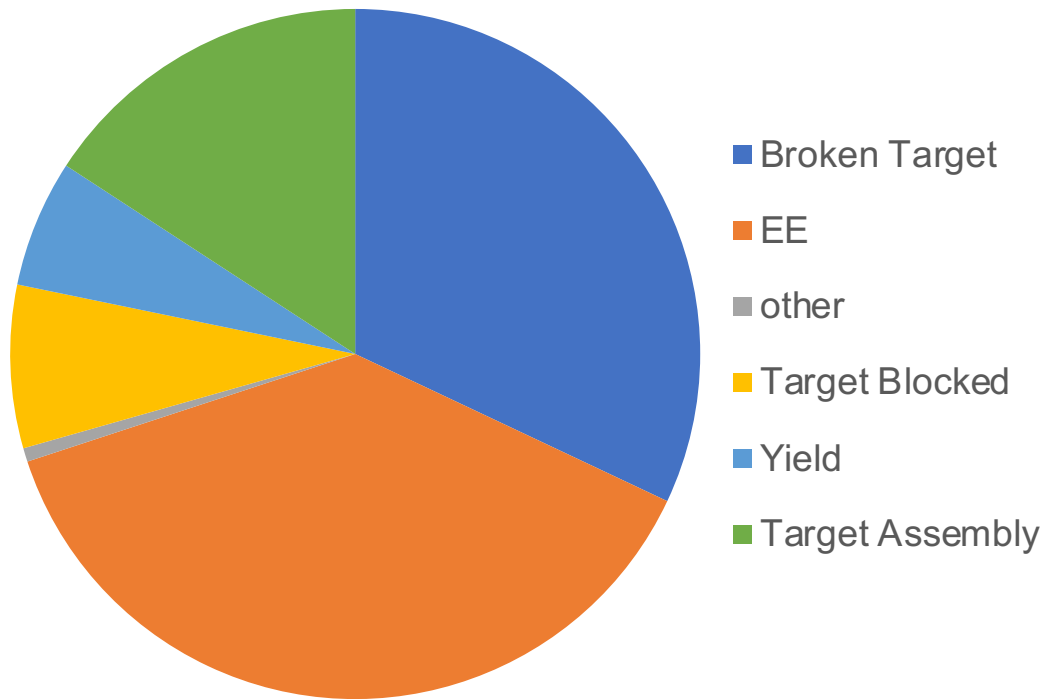
Target Downtime 2010-2019
total: 1100 hours in 10 years

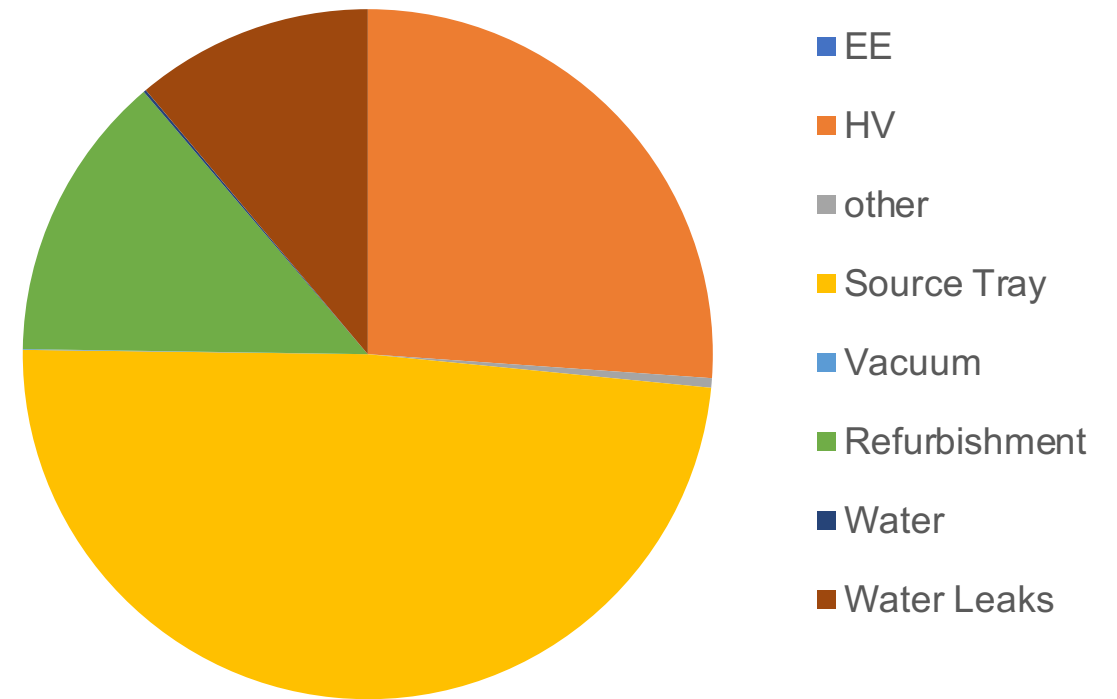
Target Module Downtime 2010-2019
total: 2300 hour in 10 years

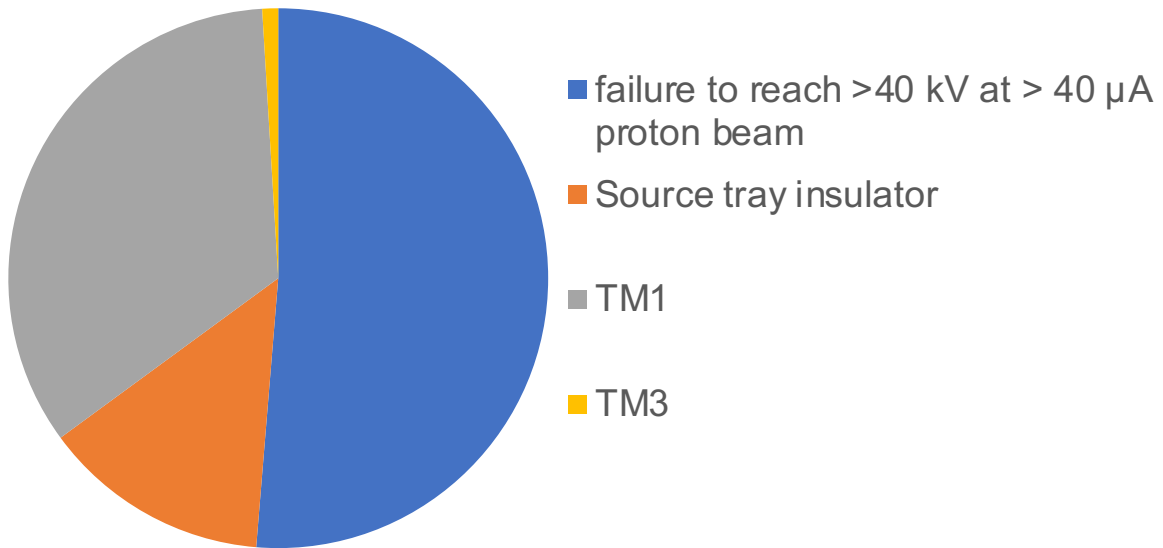
High Voltage Caused Downtime 2010-2019 total: 600 hours in 10 years

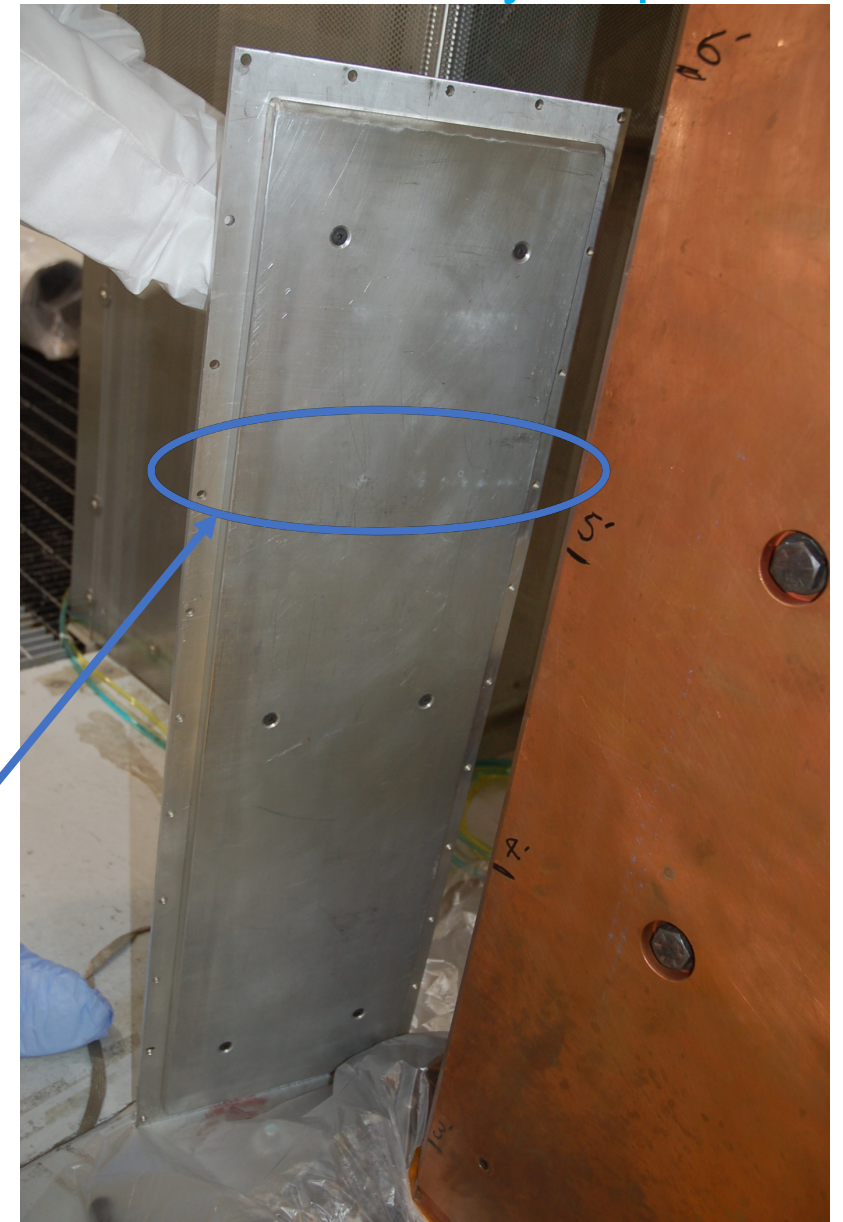
Current design

Maximum field strength: 13 kV/mm

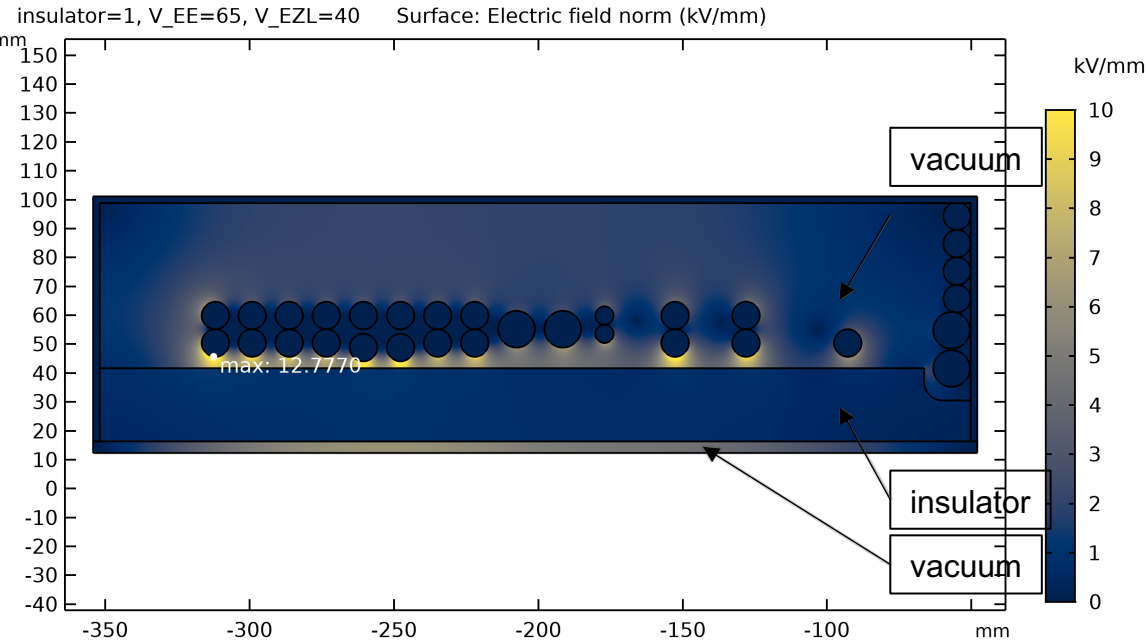
Cross section of current model

- Bias = 75 kV, EE = -10 kV, EZL = 40 kV
- High field strengths occur between service lines and insulator plate

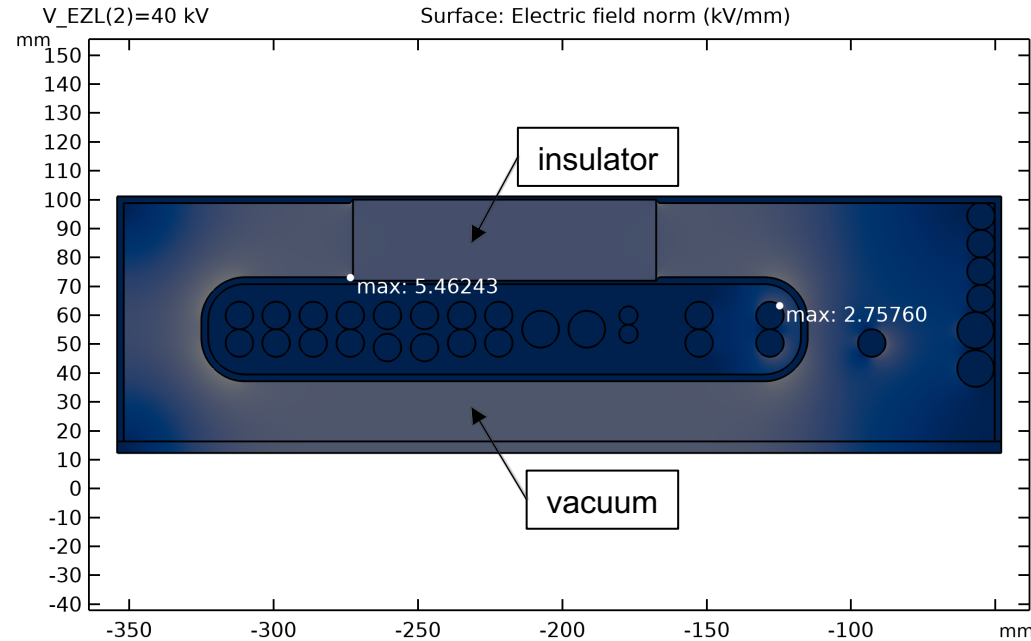
New concept

Maximum field strength: 5.5 kV/mm

Cross section of unoptimized proposed design

- Bias = 75 kV, EE = -10 kV, EZL = 40 kV
- Enclosing service lines at high voltage significantly reduces field strength
- Detailed design finished in beginning 2020

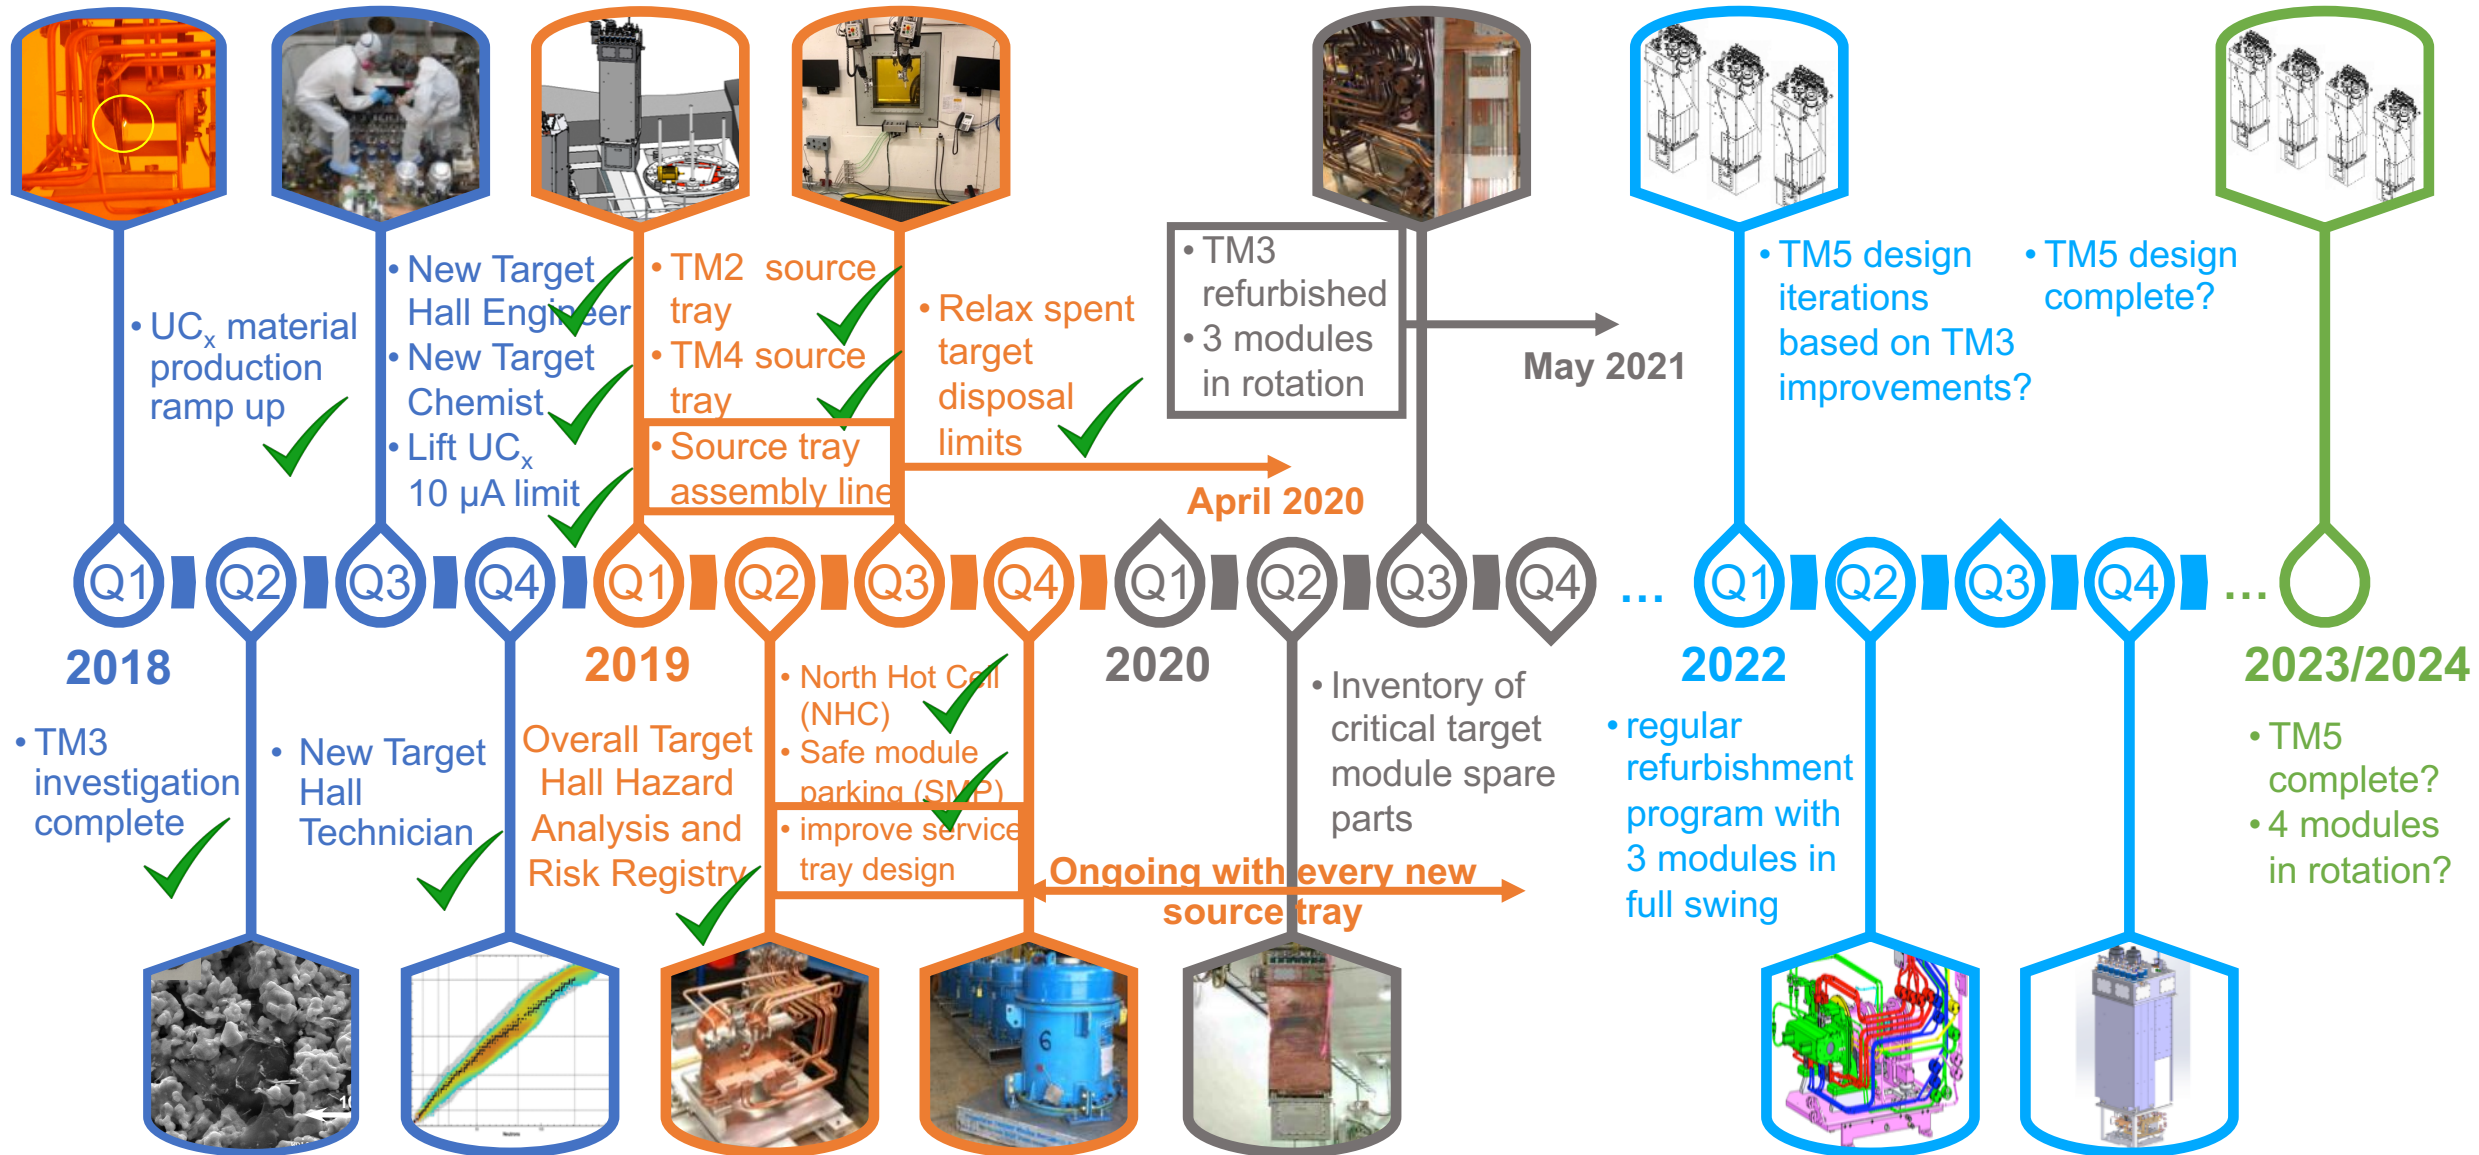
Target Infrastructure Improvement Strategy – Est. Q2 2018, progress compared to initial time line
